# STATE OF THE WATERSHED

Annual Newsletter of the Big Dry Creek Watershed Association

**BIG DRY CREEK** December 2015

## Big Dry Creek 2014 Water Quality and Biological Monitoring Review

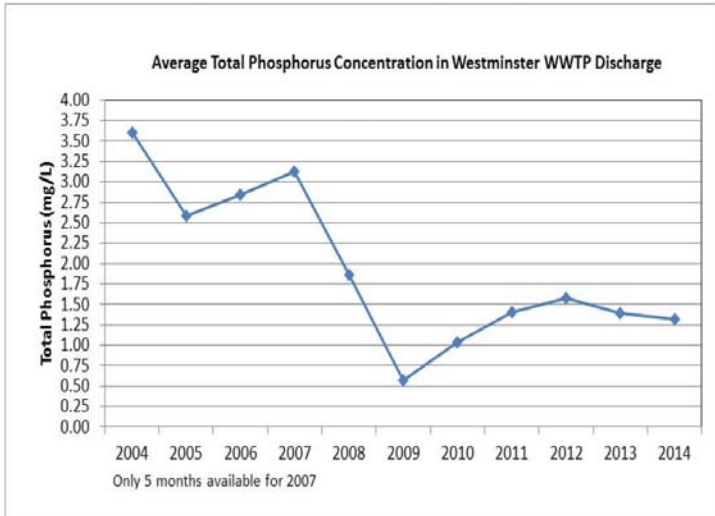
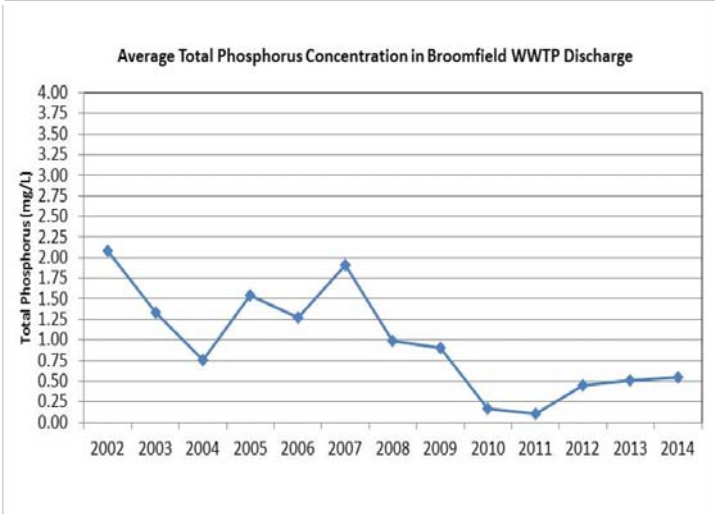
5. Phosphorus concentrations and loads to Big Dry Creek have decreased due to enhanced treatment processes at the Broomfield and Westminster WWTPs (see graphs), along with reuse programs that continue to be implemented at these WWTPs.

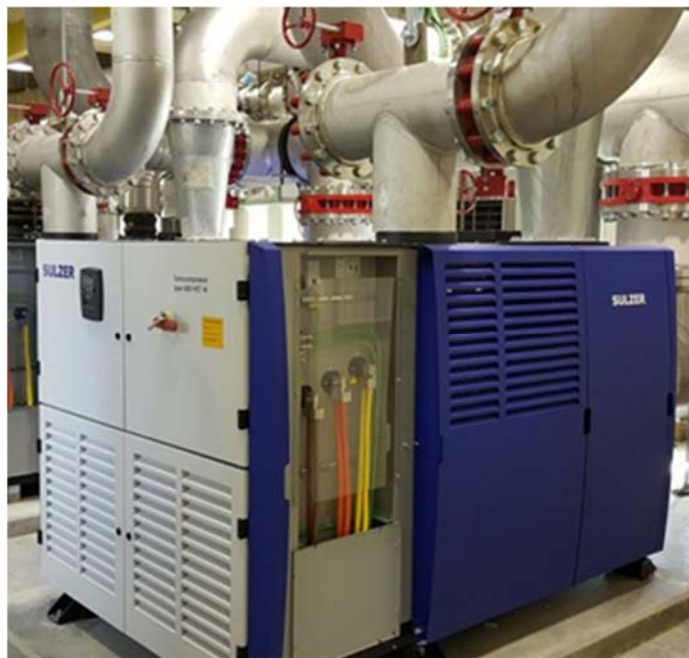
*New turbo blowers (manufactured by Sulzer-ABS).*

- 1. Blower & Aeration Control Upgrades.** The turbo blowers are currently being installed and will start up December 15, 2015. With magnetic bearings designed for minimal energy loss and no mechanical wear, the blowers are projected to reduce energy costs by 30% and provide better regulated and controlled flow rates to enhance nutrient removal.
- 2. Centrate Return Pump System Modifications.** The new centrate return pump system came on-line in September 2015. The original pumping equipment pumped large volumes of centrate in a short period of time, resulting in a significant ammonia load being reintroduced to the treatment processes over a short period of time. The upgrade included changing out the centrifugal pumps for progressive cavity pumps with variable frequency drive controls. The pump rate can now be controlled throughout the day allowing for a more stable feed rate.
